REPORT OF MARINE SURVEY

"Vessel Name"

198- Hunter 3-

Survey date

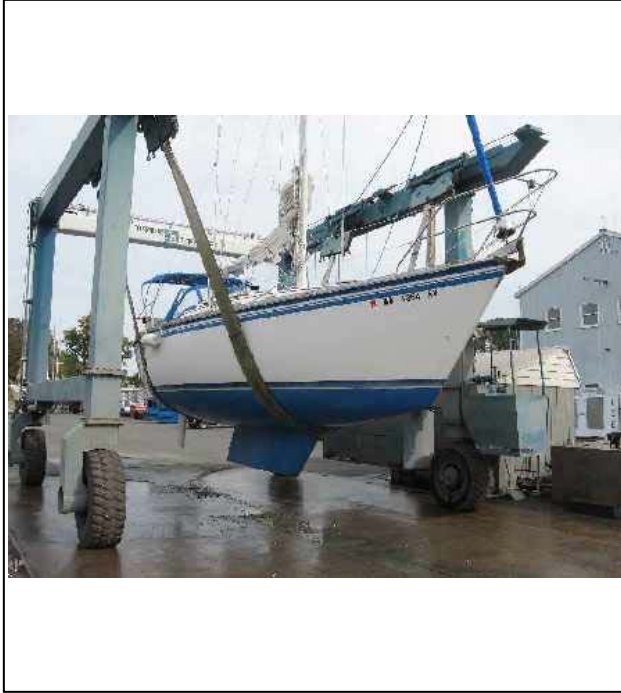
White gelcoat with Navy blue boot stripe. The boot stripe appears to have been repainted and the out side layer of paint is wearing off .

Finding C.1 Boot stripe Paint Wear

White gelcoat with Navy blue boot stripe. The boot stripe appears to have been repainted and the out side layer of paint is wearing off .	
FINDINGS	RECOMMENDATIONS
The boot stripe appears to have been repainted and the out side layer of paint is wearing off.	<i>Investigate further and repair or renew as necessary.</i>

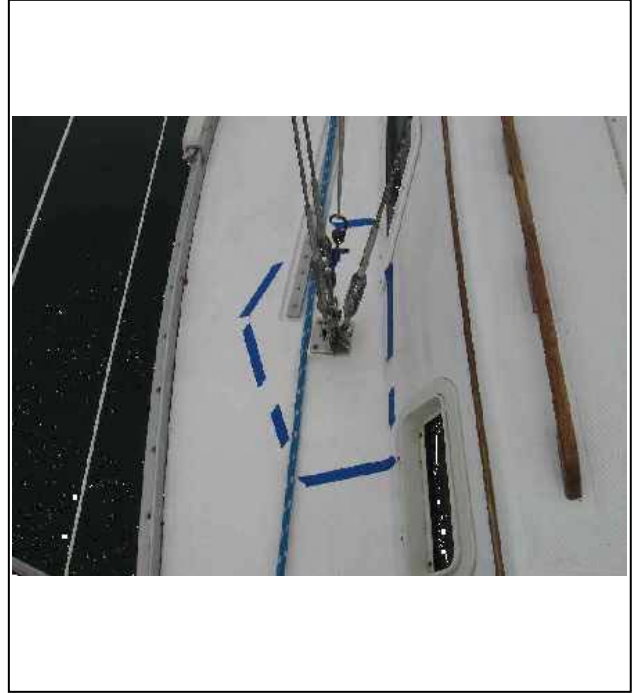
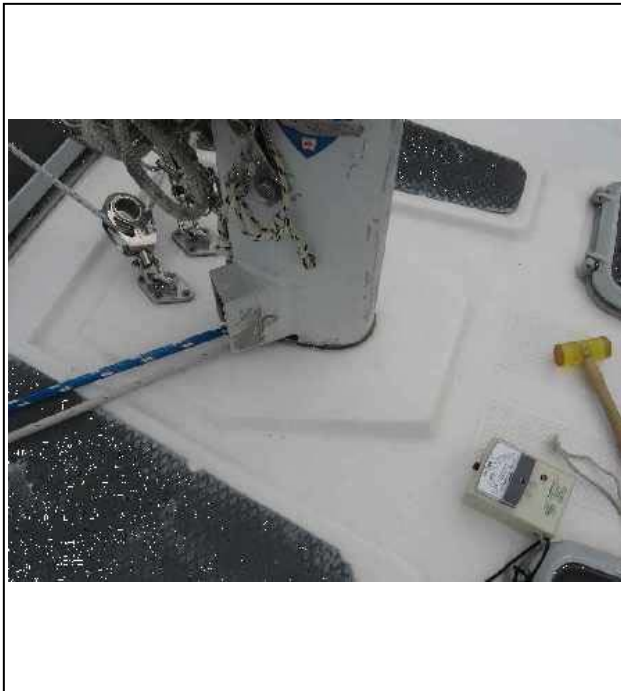
Cored FRP (fiber reinforced plastic) Core material undetermined. The decks were tapped with a phenolic hammer and checked with a moisture meter approximately every six inches. Two (2) areas of the deck were found to have or show moderate moisture content readings. One area is to starboard around the chain plate fitting. An area approximately 6 inches by 8 inches, see finding photo. Extending out from this area is a slightly larger area of what appears to be delamination. This area is approximately 12 inches by 20 inches, extending from the chain plate across to the toe rail. The second area with moderate to high moisture readings is the area around the mast step plate. An area approximately 10 inches by 10 inches and confined to the raised area of the deck around the mast step. No delamination was detected with sounding in this area.

Finding C.2 Area of Elevated Moisture Reading

FINDINGS	RECOMMENDATIONS
<p>Cored FRP (fiber reinforced plastic) Core material undetermined. The decks were tapped with a phenolic hammer and checked with a moisture meter approximately every six inches. Two (2) areas of the deck were found to have or show moderate moisture content readings. One area is to starboard around the chain plate fitting. An area approximately 6 inches by 8 inches, see finding photo. Extending out from this area is a slightly larger area of what appears to be delamination. This area is approximately 12 inches by 20 inches, extending from the chain plate across to the toe rail. The second area with moderate to high moisture readings is the area around the mast step plate. An area approximately 10 inches by 10 inches and confined to the raised area of the deck around the mast step. No delamination was detected with sounding in this area.</p>	<p><i>Investigate further and repair or renew as necessary.</i></p>

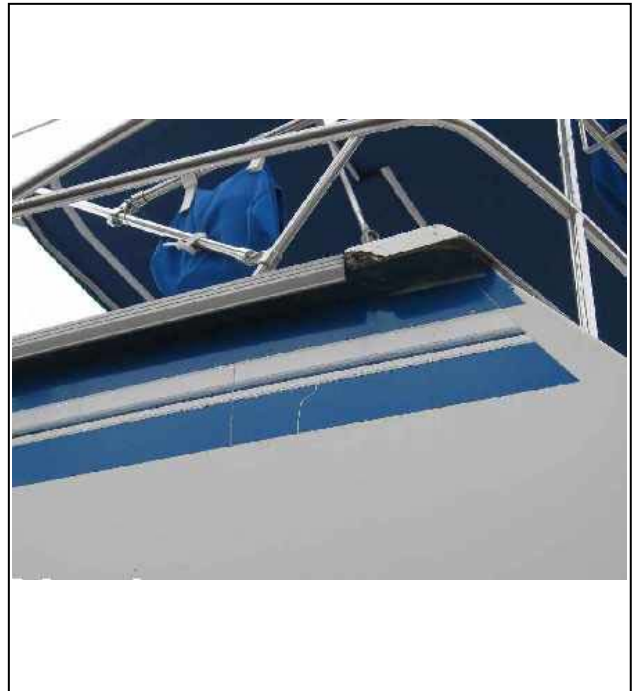
The hull to deck joint is of the deck overlap type (coffee can approach) with fasteners through an aluminum rub rail which extends from bow to stern on the out side of the vessel . Appeared serviceable where sighted. All fasteners can be sighted from the out side of the hull. At the port aft corner of the toe rail there is a short section of FRP deck, where the aluminum toe rail ends, which is broken off. This section is approximately 1 by 2-3 inches in size.

Finding C.3 Toe Rail Damage

FINDINGS	RECOMMENDATIONS
<p>At the port aft corner of the toe rail there is a short section of FRP deck, where the aluminum toe rail ends, which is broken off. This section is approximately 1 by 2-3 inches in size.</p>	<p><i>Investigate further and repair or renew as necessary.</i></p>

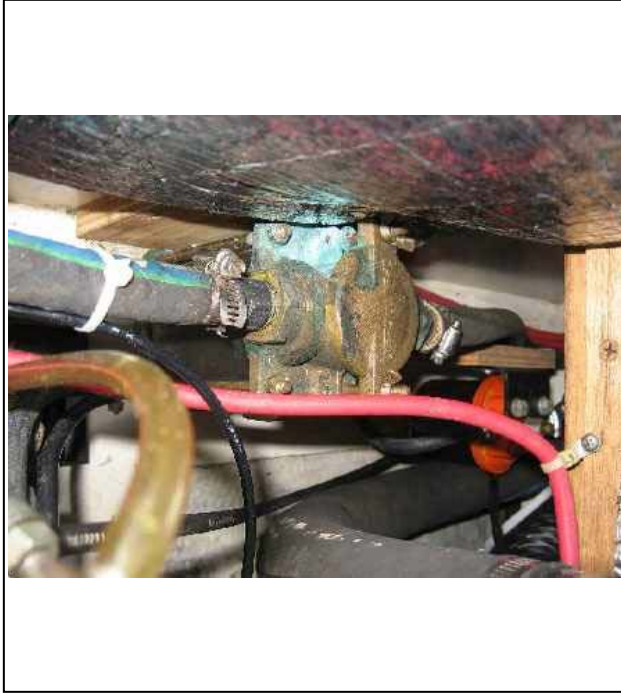
The Bronze engine raw water strainer was mounted to starboard and aft of the engine. All hoses were single clamped and the strainer appeared clear when sighted with a flash light. There is some surface corrosion forming on the starboard side of the engine raw water filter cover plate and hold down bolts.

Finding C.5 Corrosion on Engine Raw Water Filter

The Bronze engine raw water strainer was mounted to starboard and aft of the engine. All hoses were single clamped and the strainer appeared clear when sighted with a flash light. There is some surface corrosion forming on the starboard side of the engine raw water filter cover plate and hold down bolts.	
FINDINGS	RECOMMENDATIONS
There is some surface corrosion forming on the starboard side of the engine raw water filter cover plate and hold down bolts.	<i>Investigate further and repair or renew as necessary.</i>
